**DAM SAFETY INSPECTION REPORT  
LIBERTY LAKE DAM  
OKLAHOMA INVENTORY ID: OK02122  
FOR  
THE CITY OF GUTHRIE  
LOGAN COUNTY, OKLAHOMA  
DECEMBER 2014  
MECE 211135.104**

**Dam Safety Inspection Report  
Liberty Lake Dam  
For  
City of Guthrie  
Logan County, Oklahoma  
December 2014**

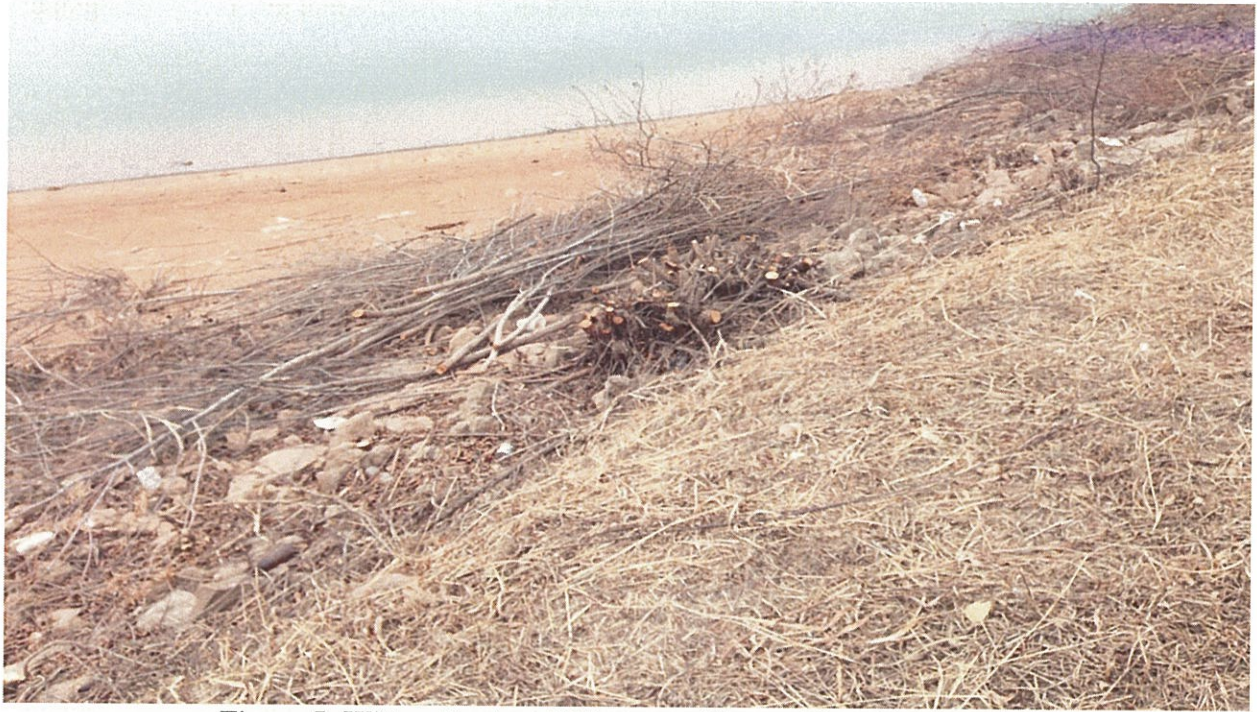
**Figure 5: Willow Root on E Upstream Slope – Photo Facing SSW**

- B. Recommendations:
1. Plant grass seed mix along downstream dam slope.
  2. Continue repair of areas of erosion and riprap as needed after root system removal on upstream slope of dam.

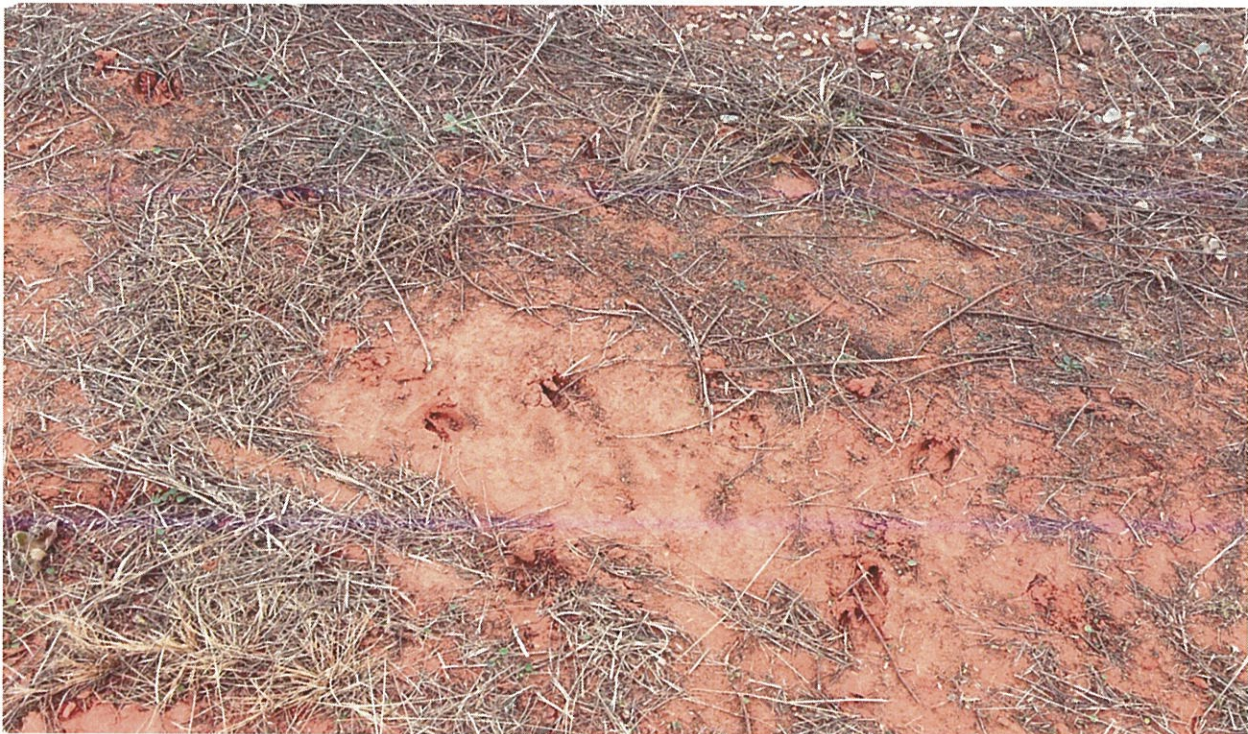
**Figure 12: Whitetail Deer Tracks on Downstream Slope at East End of Dam**

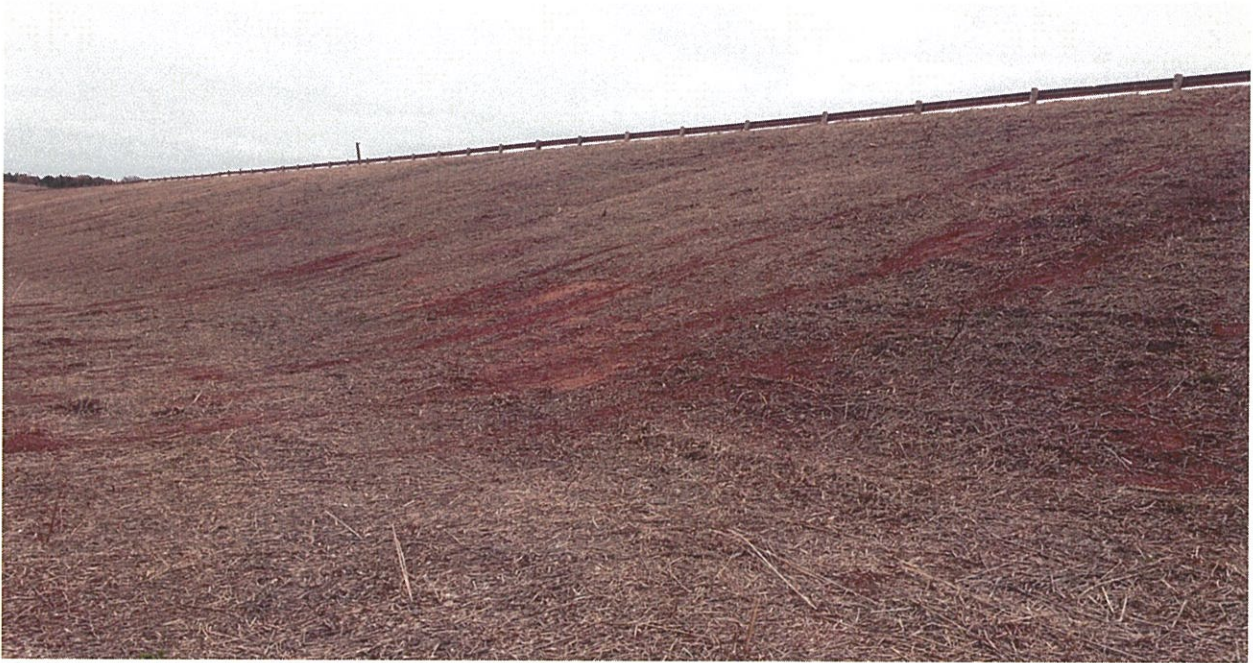
The downstream slope of the dam was in overall poor condition. The downstream slope of the dam was recently mowed. There is inadequate grass cover and numerous bare spots were observed. No severe erosion was observed on the slopes of the dam. Several large trees and shrubs are growing just past the toe. A few rodent holes were observed. Seepage and standing water were observed at the toe of the dam. Figures 16 and 17 are aerial images that show the location of the observed standing water at the toe of the dam. The area near the standing water was saturated. The water did not appear to be flowing, nor did it appear to be excessively cloudy; however, further investigation is necessary to ensure that the seepage is not eroding the embankment. The turbidity in the wetland at the toe of the dam should be monitored and any increase in turbidity should be reported. The toe of the dam should be monitored for increases in saturated soil areas and for boils. It is recommended that piezometers be installed on the upstream and downstream slopes of the dam at a spacing of approximately 150 to 200 feet. Several depressions were noted during the inspection along the downstream side of the dam. No seepage was noted in the depressions and the crest was not sagging; therefore the depressions along the dam were likely constructed that way. Figures 10 through 17 show the downstream slope of the dam.

**Figure 13: Inadequate Growth on Downstream Slope– Photo Facing SE**

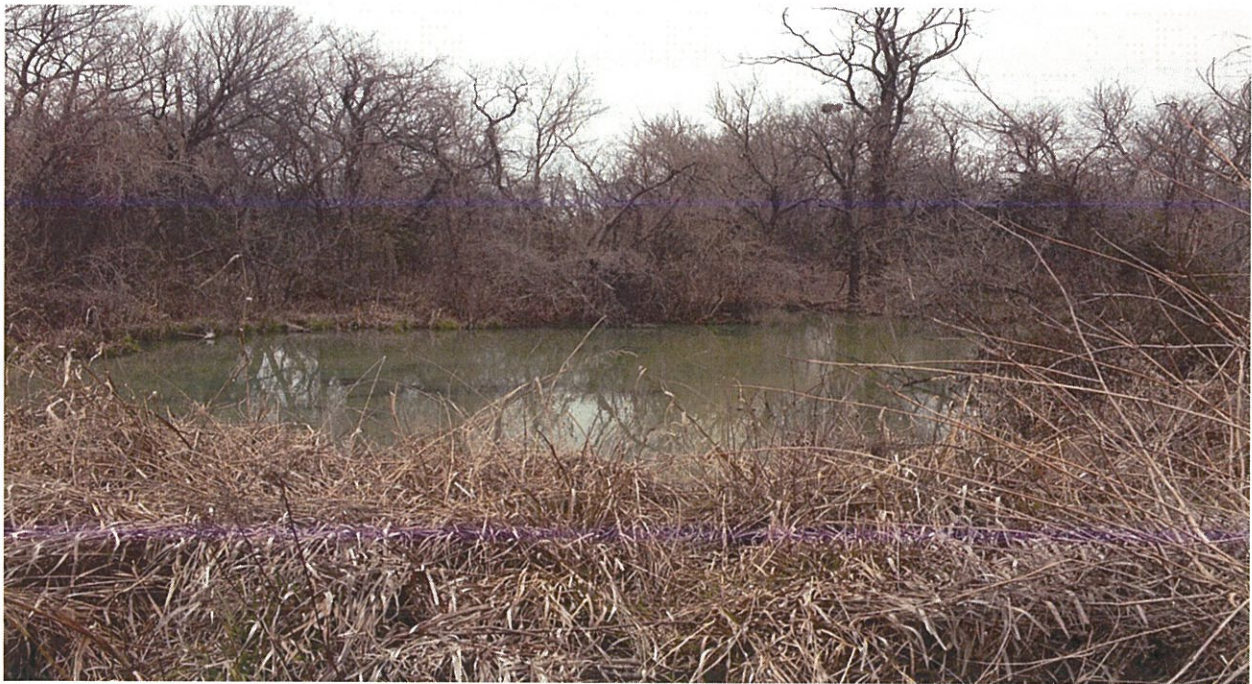
Rate of seepage at toe of dam cannot be estimated in field because seepage is into marsh. Saturated soil was observed between toe of dam and marsh. Slightly cloudy areas were observed in marsh but could have been from waterfowl observed onsite. Seepage should be observed periodically and immediately following seismic events as areas around Liberty Lake have been experiencing frequent low magnitude earthquakes.

**Figure 14: Standing Water at Toe of Dam**

7. Annually review and update the Emergency Action Plan. Send copies of updates to the Oklahoma Water Resources Board.
  8. All areas of seepage, especially at the toe of the dam, would require additional, in-depth investigation to determine the amount of seepage, the amount of soil eroding due to the seepage, and possible remedial actions. Continue to monitor seepage for signs of increasing seepage rates.

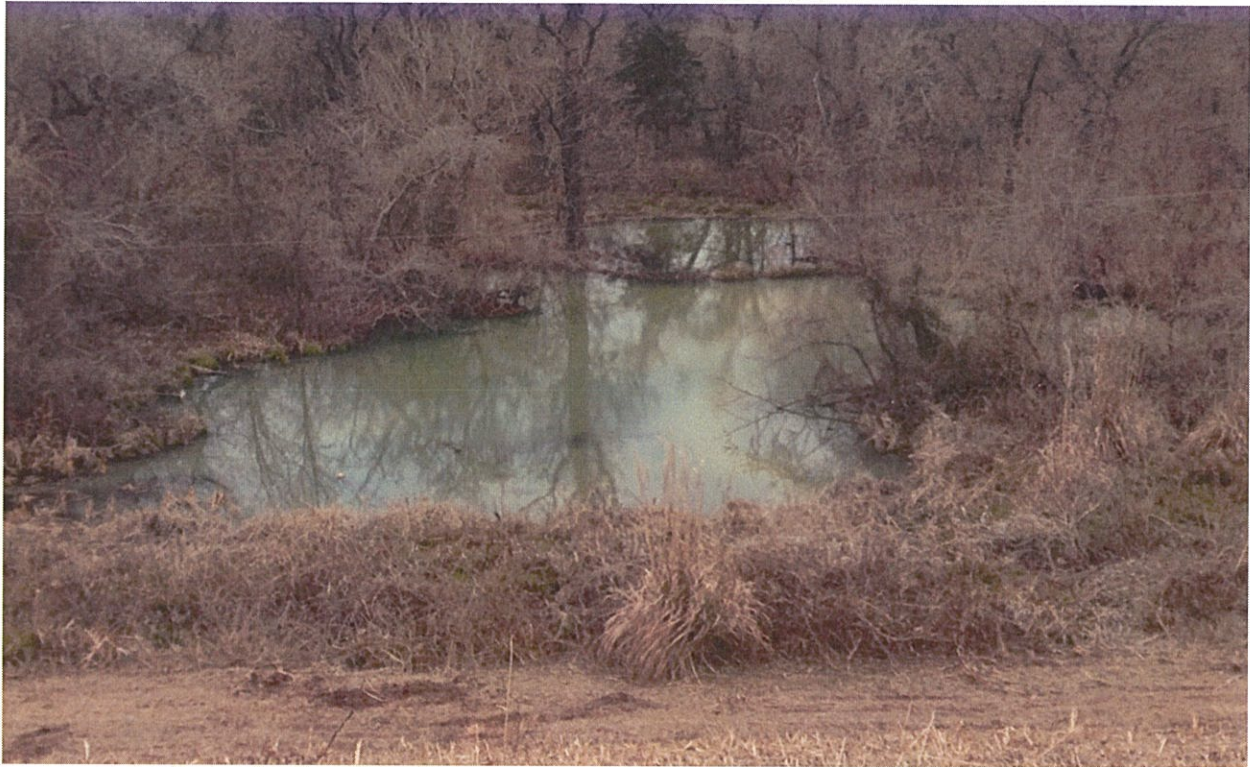
**Figure 15: Standing Water at Toe of Dam – Photo Facing North from Crest**

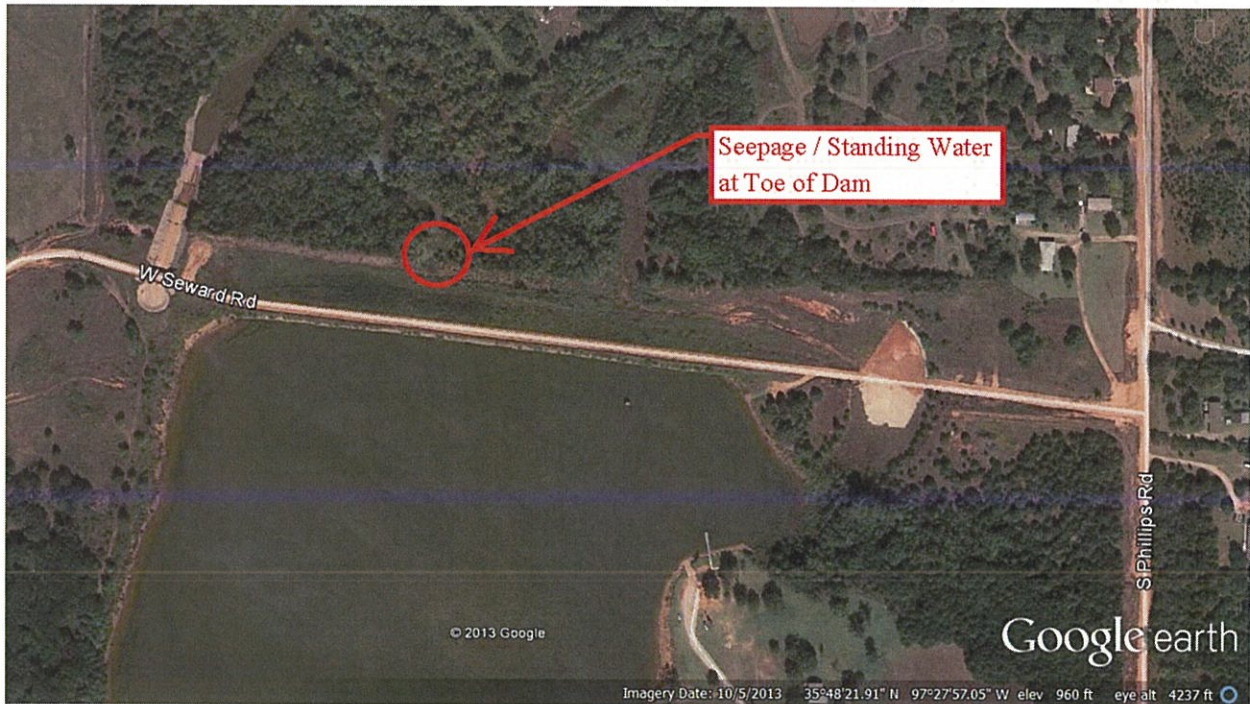
**Figure 16: Aerial Image of Location of Seepage at Toe**

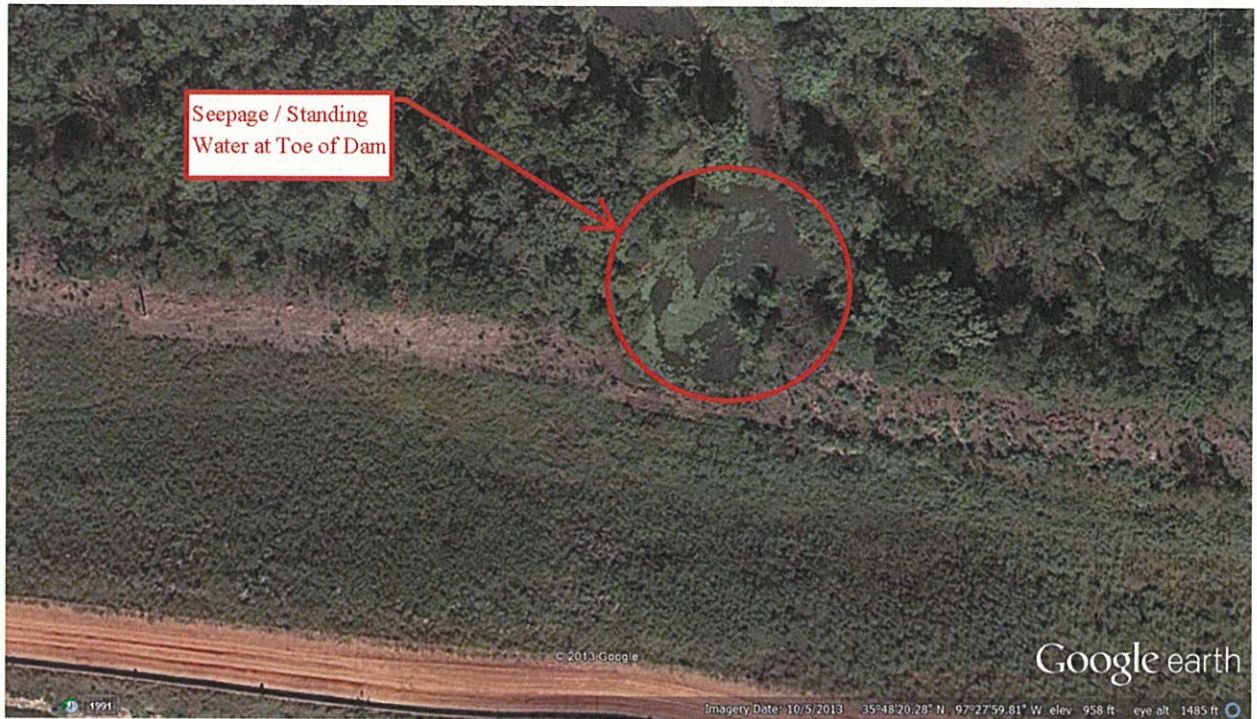
**Figure 17: Aerial Image of Seepage at Toe**

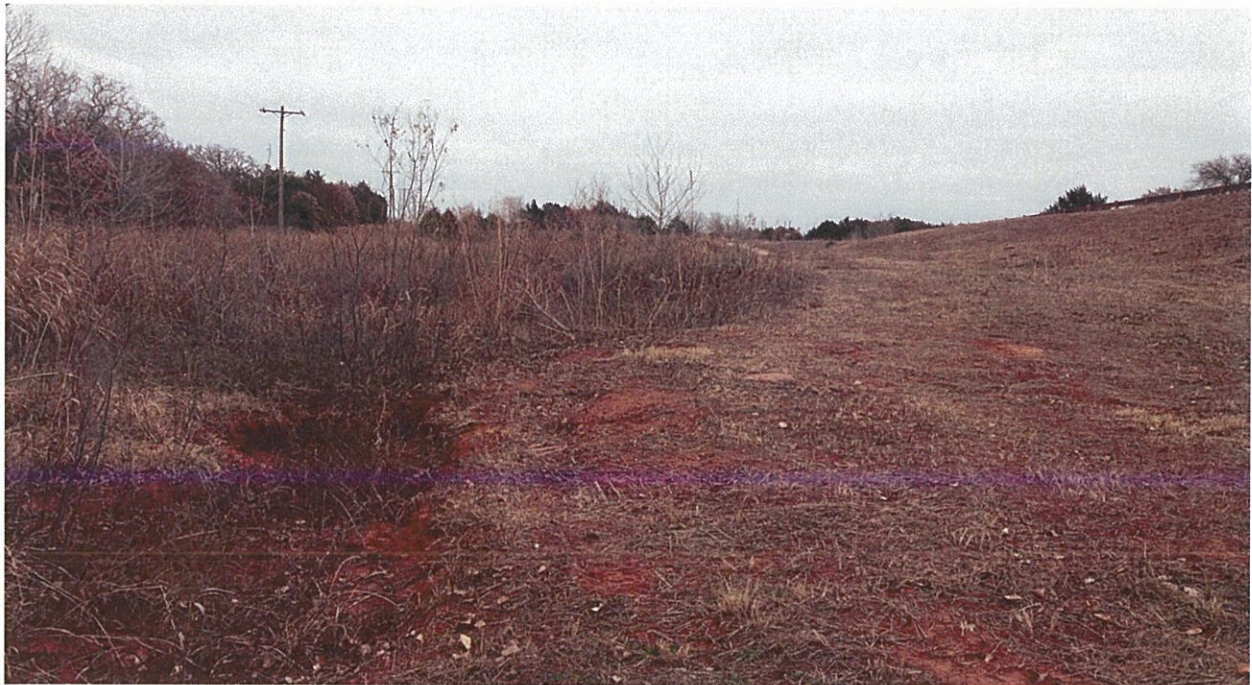
The abutment contacts were in fair condition. The east abutment on the downstream side of the dam showed signs of erosion. No seepage was noted. The area of erosion should be filled with compacted soil and lined with rip rap to prevent further scour.

The east abutment contact was in fair condition due to erosion of the soil on the downstream slope (Figure 18 and 19). The west abutment appears to be in good condition; however, seepage was observed under the spillway immediately upstream of the stilling basin (Figure 28 and 29).

**Figure 18: Erosion on East Abutment – Photo Facing East**

3. Keep detailed maintenance records.
  4. Prevent all trees and shrubs from growing on slopes.
  5. Prevent rodent activity in the embankment.
  6. Fill areas of erosion on the east embankment and place riprap to prevent future erosion.

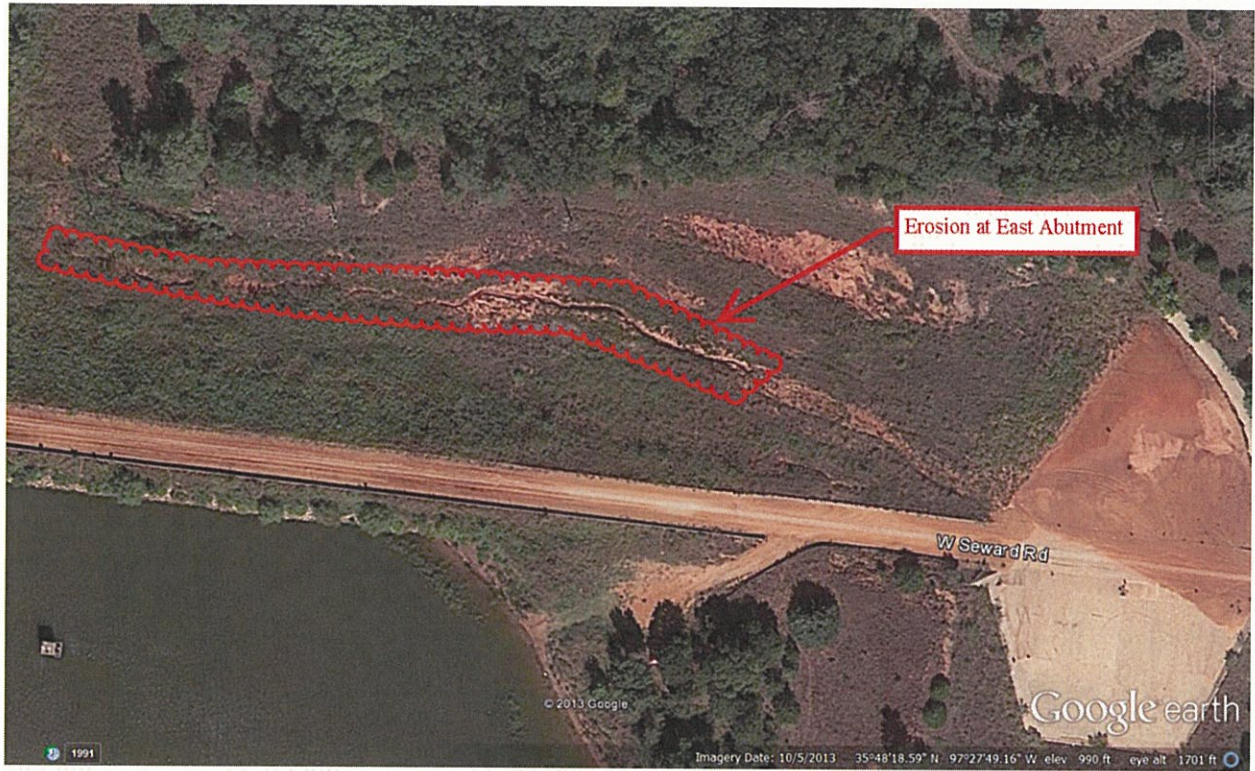
**Figure 19: Aerial Image of Erosion on East Abutment**

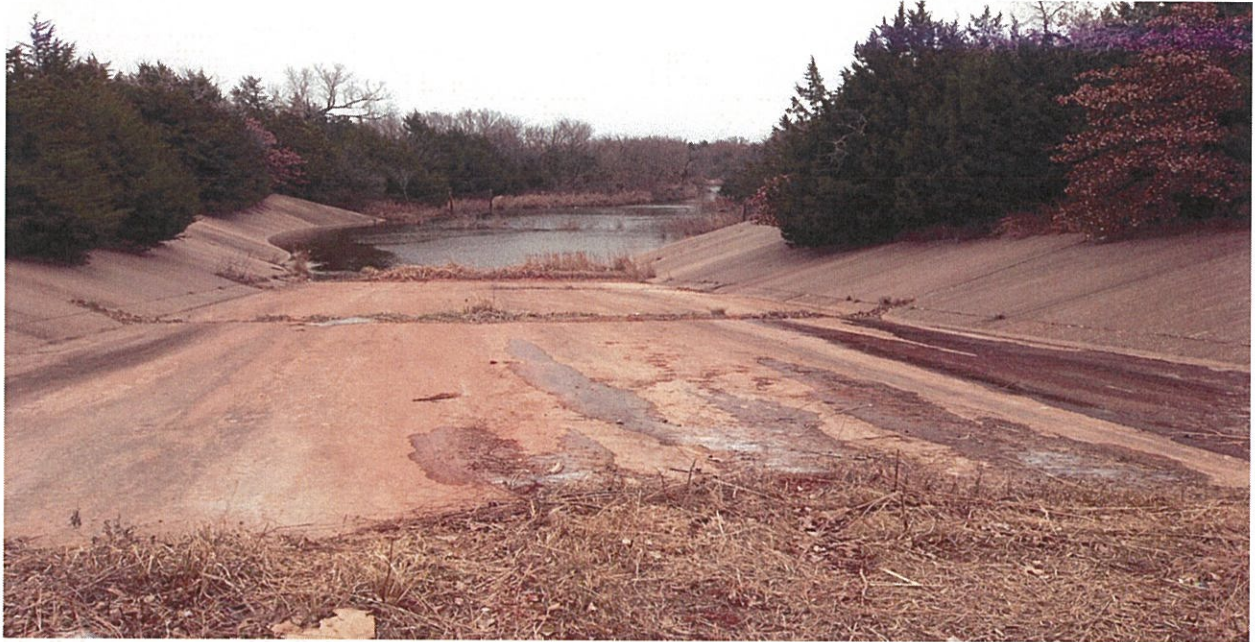
The concrete spillway (west spillway) was in fair condition. There was some spalling noted at the joints and some minor cracking throughout the spillway. Minor seepage was observed through the joints near the outfall. The spillway joints also have vegetation growing through them, which indicates lost joint material. Figures 25 through 30 show the west spillway.

**Figure 2827: Seepage through Joint on West Side of the West Spillway Channel**

9. Remove all vegetation from joints in concrete and seal joints.

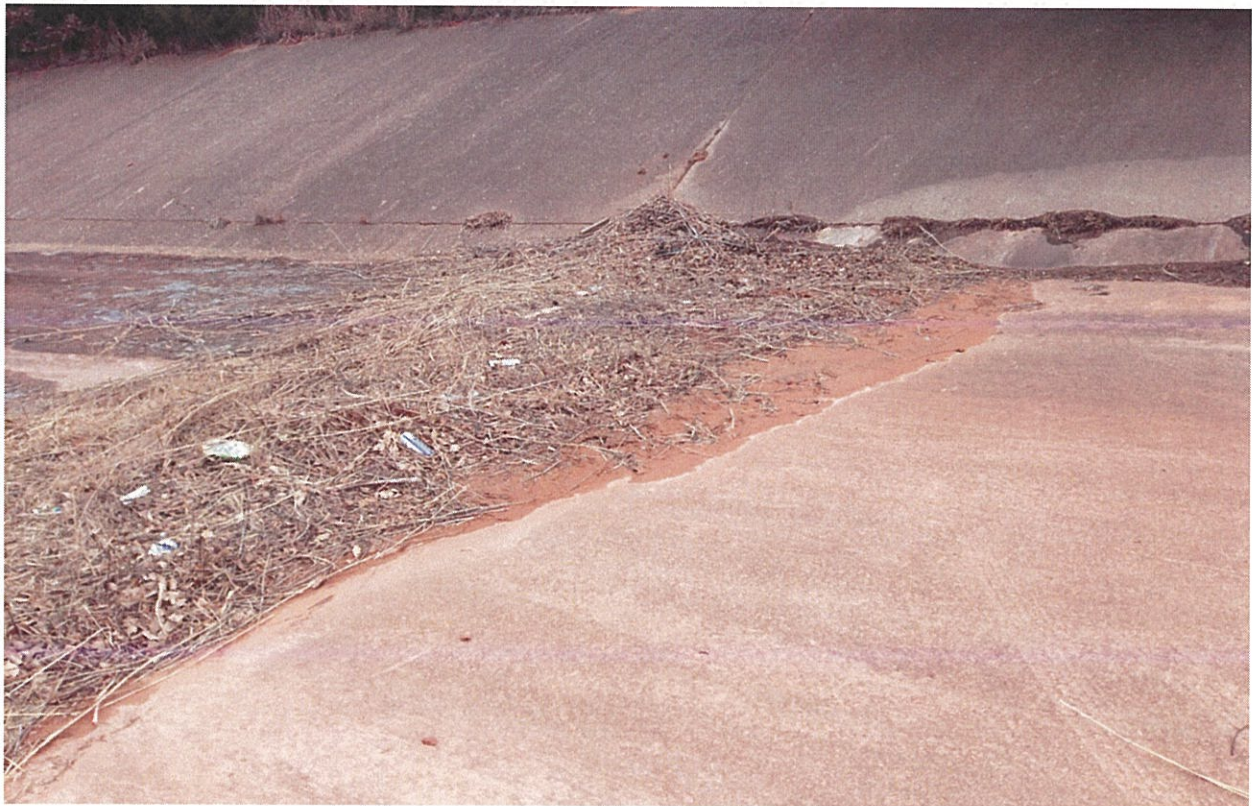
**Figure 29: Seepage and Vegetation through Joints in West Spillway Channel**

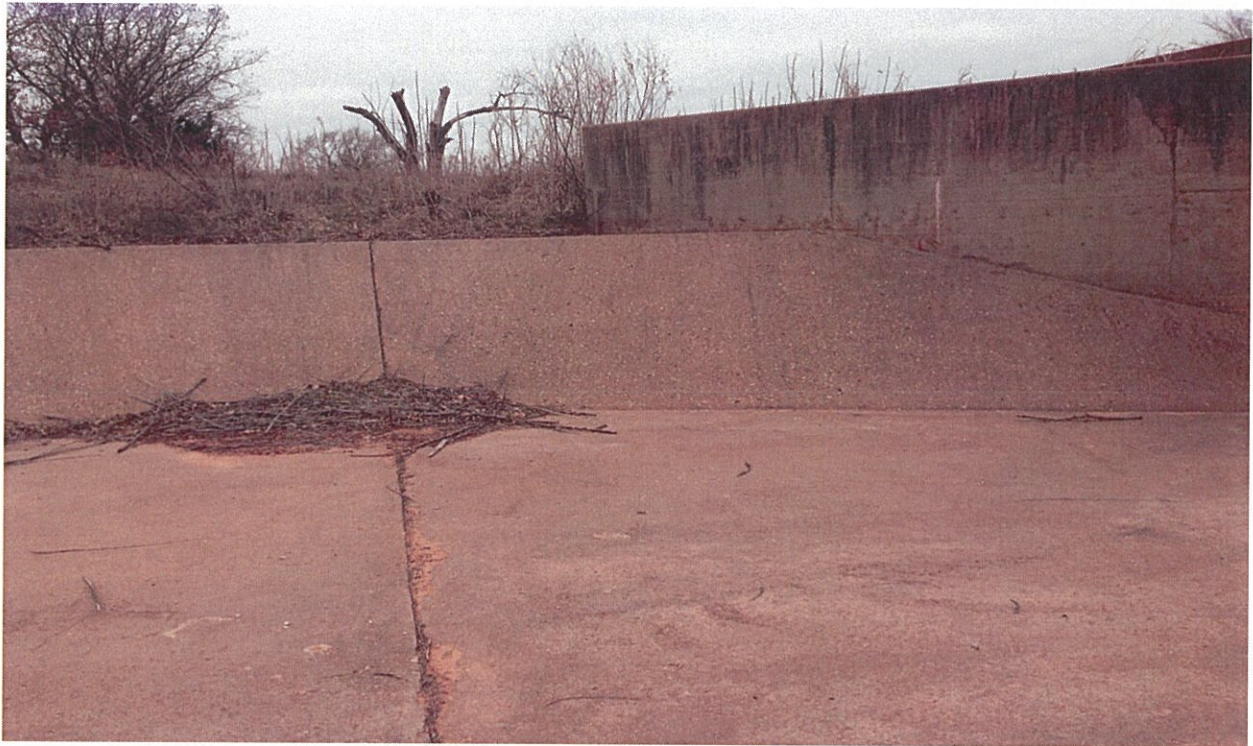
**Figure 28: Spalling at Joint in West Spillway Channel**

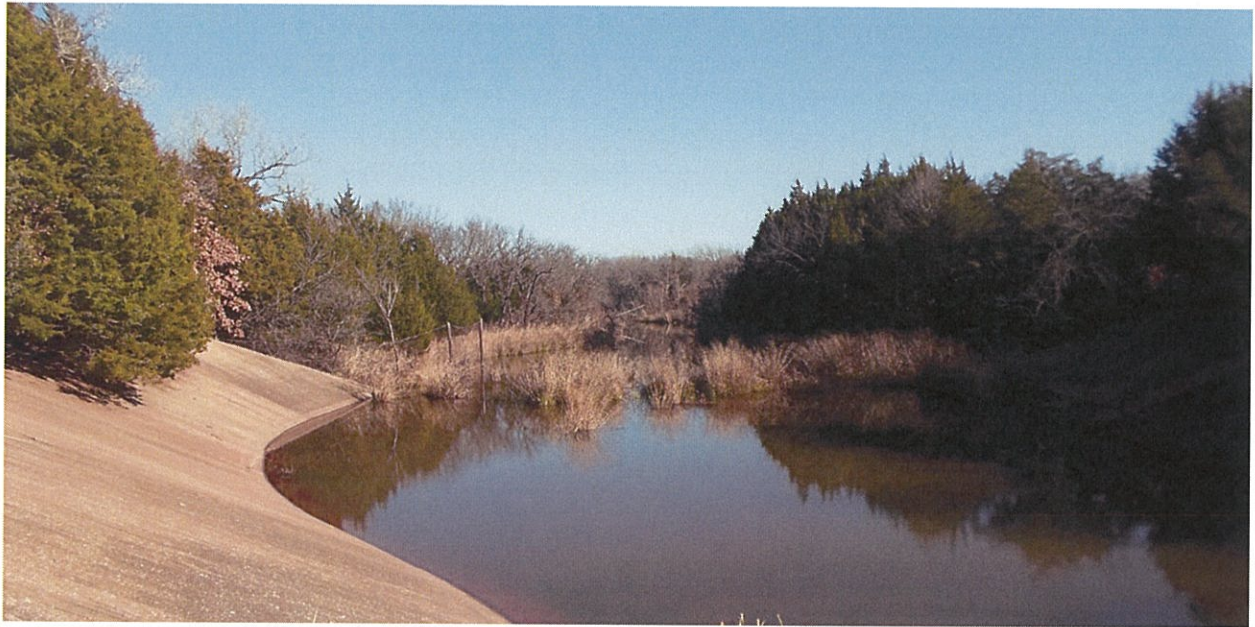
The stilling basin was in satisfactory condition. There was some minor scaling noted on the concrete, but no exposed reinforcement, offset joints, leaking joints, or excessive vegetation were observed. See Figure 34 for the stilling basin.

**Figure 32: Stilling Basin - Photo Facing NNE**
